NORDCO - INTERNATIONAL DEPARTMENT

NRS200
PRIME

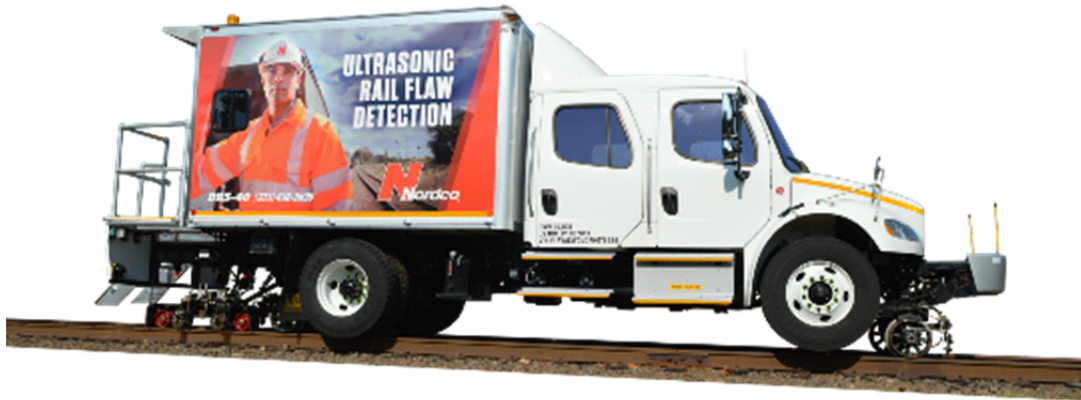
NRS200

- Vehicle Test Speed up to 50 kilometers per hour under optimal rail conditions
- Optimal Test Speed is 32 kilometers per hour
- Testing temperature -29°C to 43°C

- Gross Vehicle Weight: 10,500 kilograms
- Freightliner M2 Crew Cab with 4 DOT approved seats
- Vehicle width is 3.0 meters with extended mirrors
- Vehicle Height is 3.8 meters on highway

- Vehicle Length is 9.9 meters with rear stairs retracted
- Cummins **International** Version 6.7 liter Diesel Engine, 149 kW @ 2300 RPM, 760 Nm @ 1600 RPM, **designed for use with non-ULSD fuel**

- Standard Brakes (non-air)
- 568 liters capacity for couplant
- 379 liters capacity for diesel fuel
- Full-size 4 passenger, high roof vehicle for greater operator comfort

- Full height pass through between front truck cab and rear body to allow all passengers to exit from rear of vehicle and onto center of track during rail testing/inspection

- 14" Hydraulic Hyrail Gear, with exterior hydraulic controls for lifting and lowering
- LED Rail Test and carriage light kits for night testing
- Exterior deck mounted, dual compartment storage box for accessories and large spare parts

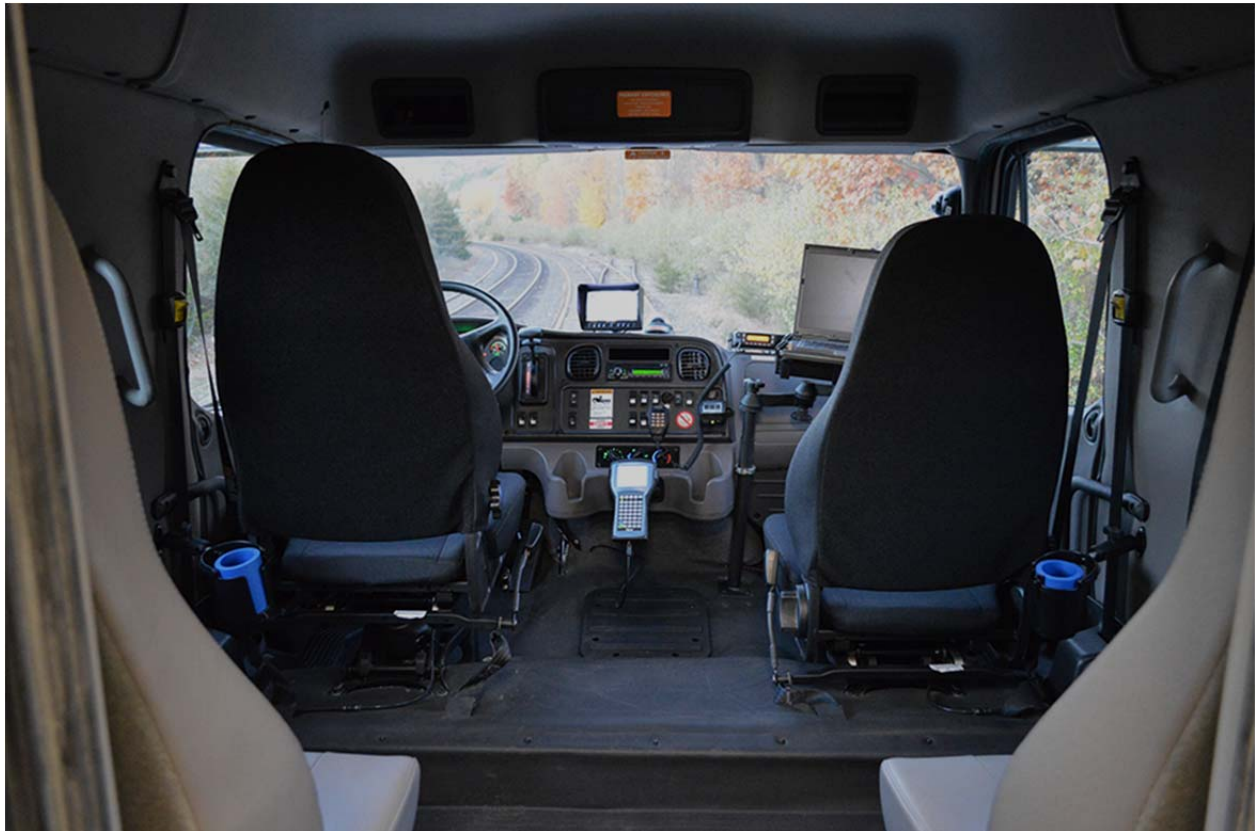
Four Person Crew Cabin

- **Air seats** for driver and passenger; cup holders for all seats
- **Air Horn**
- **Special Controls** for Rail Shunt, Hyrail Break, Strobe Light, Emergency Pump, PTO Pump
- **Backup Camera Monitor**
- **Wiring for Railroad Radio** with external loudspeaker mounted on the rear deck (Radio supplied by customer)
- Front & Driver facing **cameras** (3MP)
- **Pilot Laptop workstation** with HDMI link to Operator Monitor 3
- **QSI Driver Input Device**

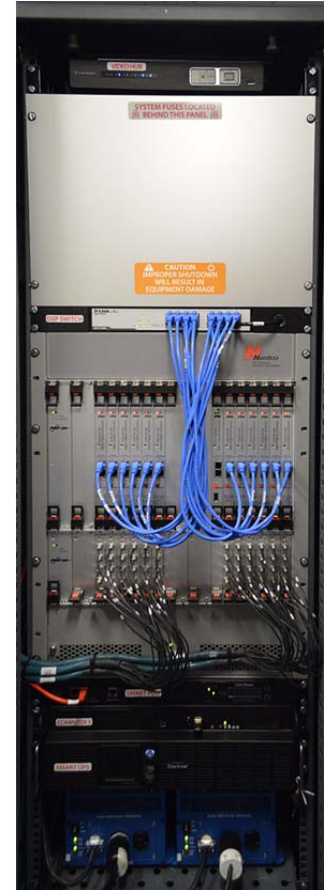
Electronics System

- Advanced **48 channel Digital Platform** for precision ultrasonic testing applications
 - **Simultaneous Processing** of multiple test channels
 - **High-Pulse Densities** and **Testing Speeds**, for enhanced defect detection and throughput

- **System Control Computer**
 - I7 Pentium Processor, 16GB RAM, 1TB SSD Storage, 1U Rackmount
- **SMART Power Distribution Unit** with Automatic Switching

- **SMART UPS**
- (2) **Pure SIN WAVE Inverters**, offering system power supply redundancy
- **Video Surveillance Controller**
- **Wireless Router** and **Mobile Router** with tracking capability (SIM cards provided by customer)

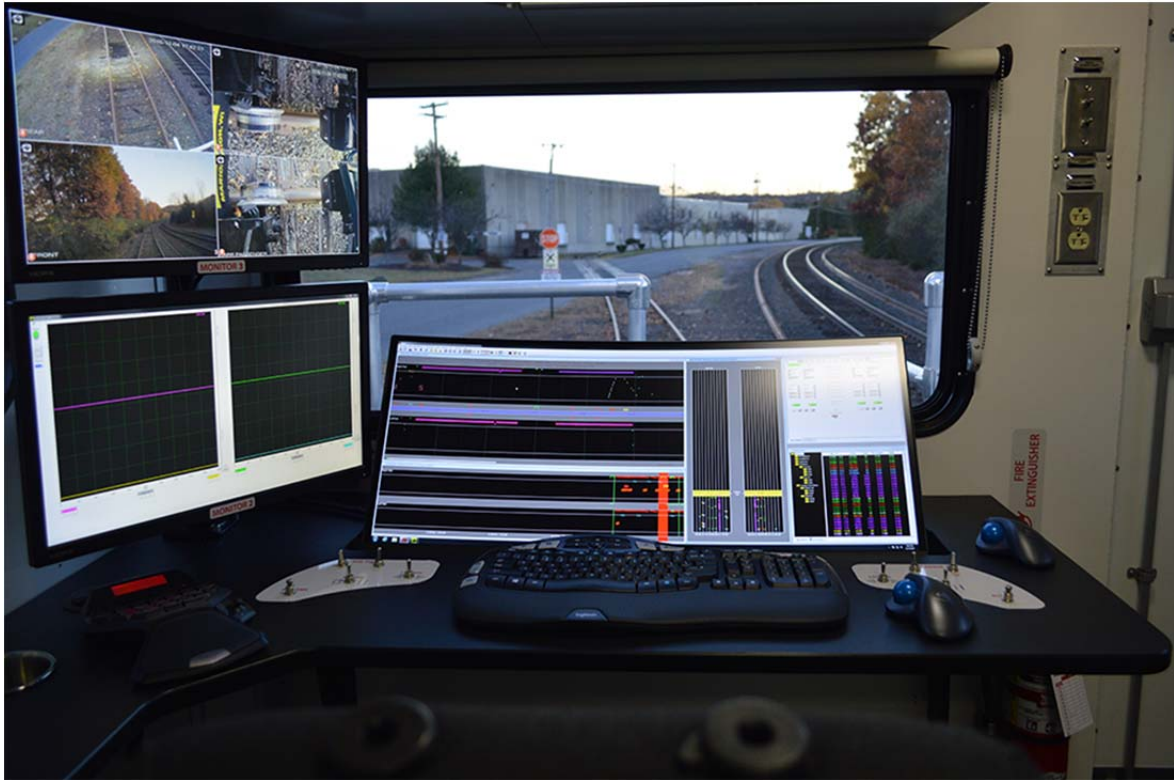
NRS-260 PRIME Chief Operator's Workstation

- Ergonomically designed Operator workstation with **direct view of the tested rail**
- **Rear Rail Egress** with deck platform and retractable stairs
- **Rail testing controls integrated** in workstation allow:
 - Adjustment of LATERAL position (Driver and Passenger side)
 - Carriage gage FOLLOW and LOCK
 - Wheel Lube (Driver and Passenger side)
 - Buzzer for communication with Driver

- Rear Air Horn
- Wheels DOWN/UP and Couplant ON/OFF
- Rear Rail Illumination ON/OFF
- Carriage UP
- Carriage Illumination ON/OFF
- **Triple Monitor Configuration**

- Monitor 1: RailTest App with BScan and other views (34" Curved, Widescreen, 3440x1440, 5MS)
 - Monitor 2: SoftScope App with 4 Channel display (21.5", 1920x1080, 1MS)

- Monitor 3: 5 Camera Video OR Pilot Display Mirror (21.5", 1920x1080, 1MS)
- **Ergonomic wireless keyboard and (2) trackball mice**
- **Ergonomic G13 BScan Icon input device**

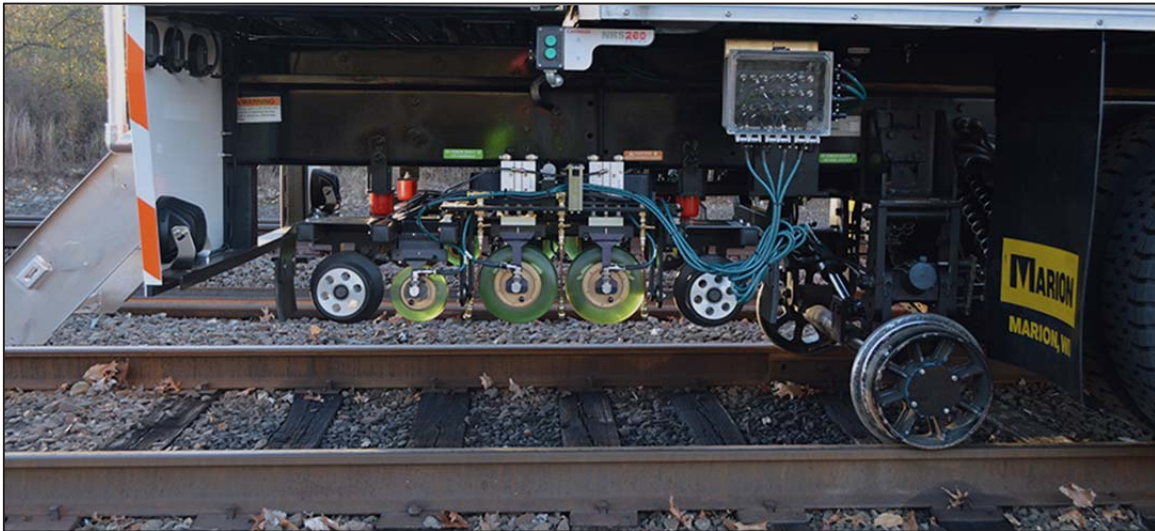
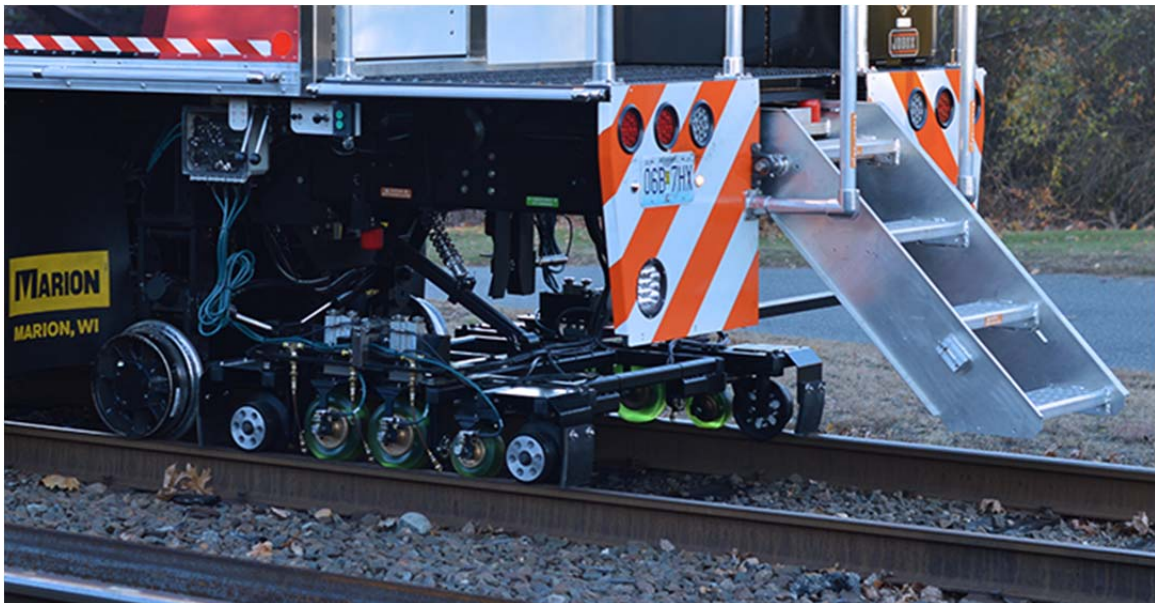
Proprietary wheel probe designs: XL9-11 RSU, Sweeper RSU, Tracer RSU

(3) wheel probes per side of carriage

Dual-rail inspection - (6) wheel probes total

Hydraulic carriage lift mechanism can be raised and lowered from the outside of the vehicle.

The carriage can be lifted from the operator workstation

Carriage cameras (3MP) on each side, monitoring the front carriage wheel

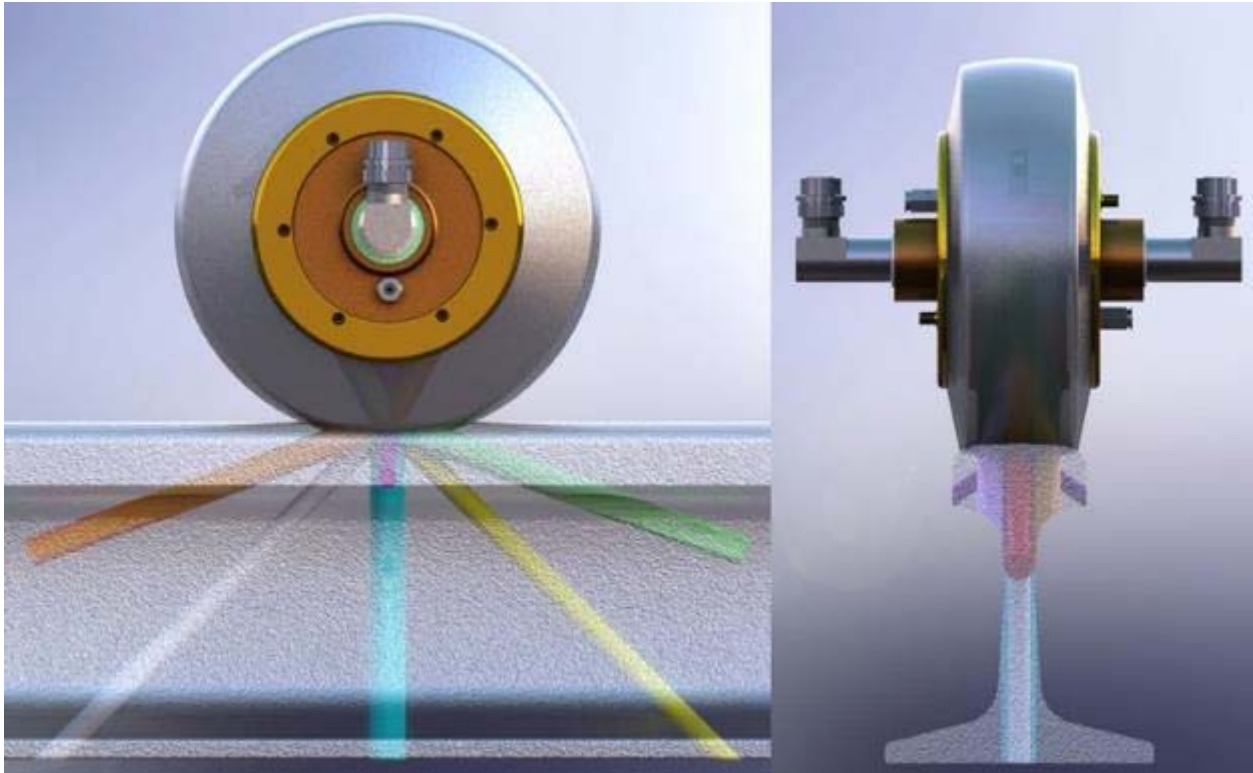
XL9-11 RSU

- zero-degree crystal for both web coverage and base detection
- 37.5° crystals (forward and backward) for full rail web coverage
- (6) 70° crystals (3 forward (field, center, gage) and 3 backward) for full head coverage
- side-looking crystals (field, gage) for longitudinal cross-rail coverage

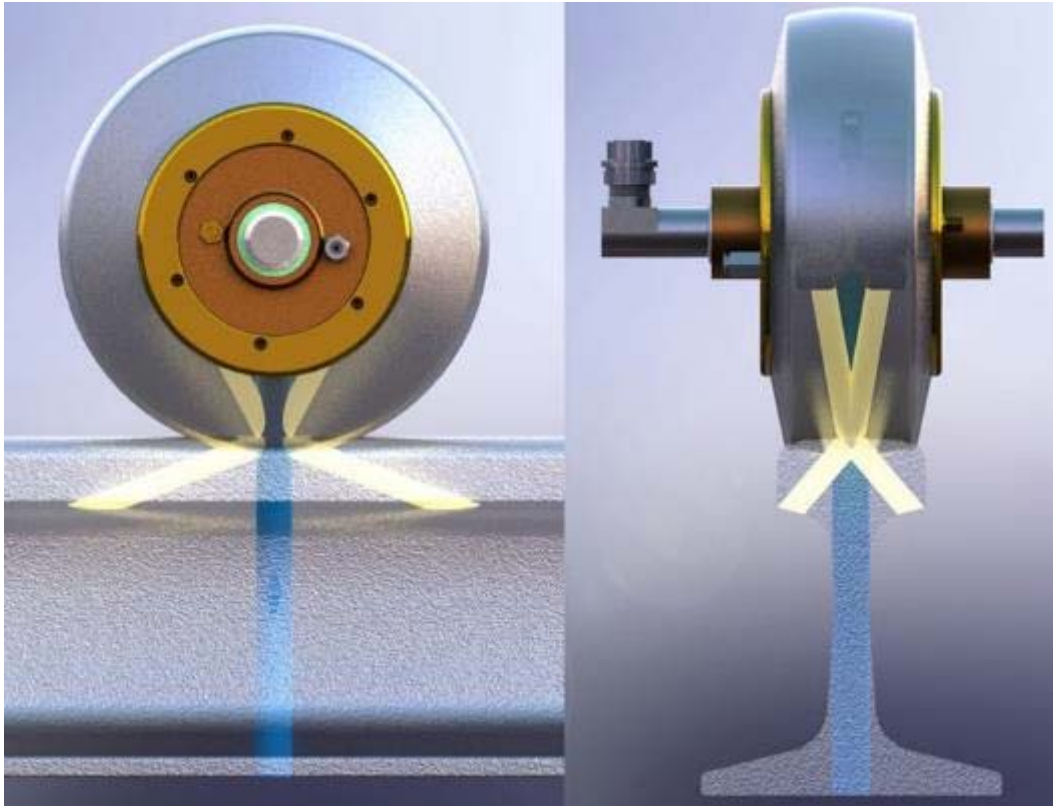
Sweeper RSU

- Optimized to detect transverse detail fractures beneath sub-surface shelling where field or gage surface conditions are inadequate for traditional detection
- zero-degree crystal for both center head coverage and base detection
- (4) proprietary shear wave angle transducers focus on head inspection in the field and gage corners

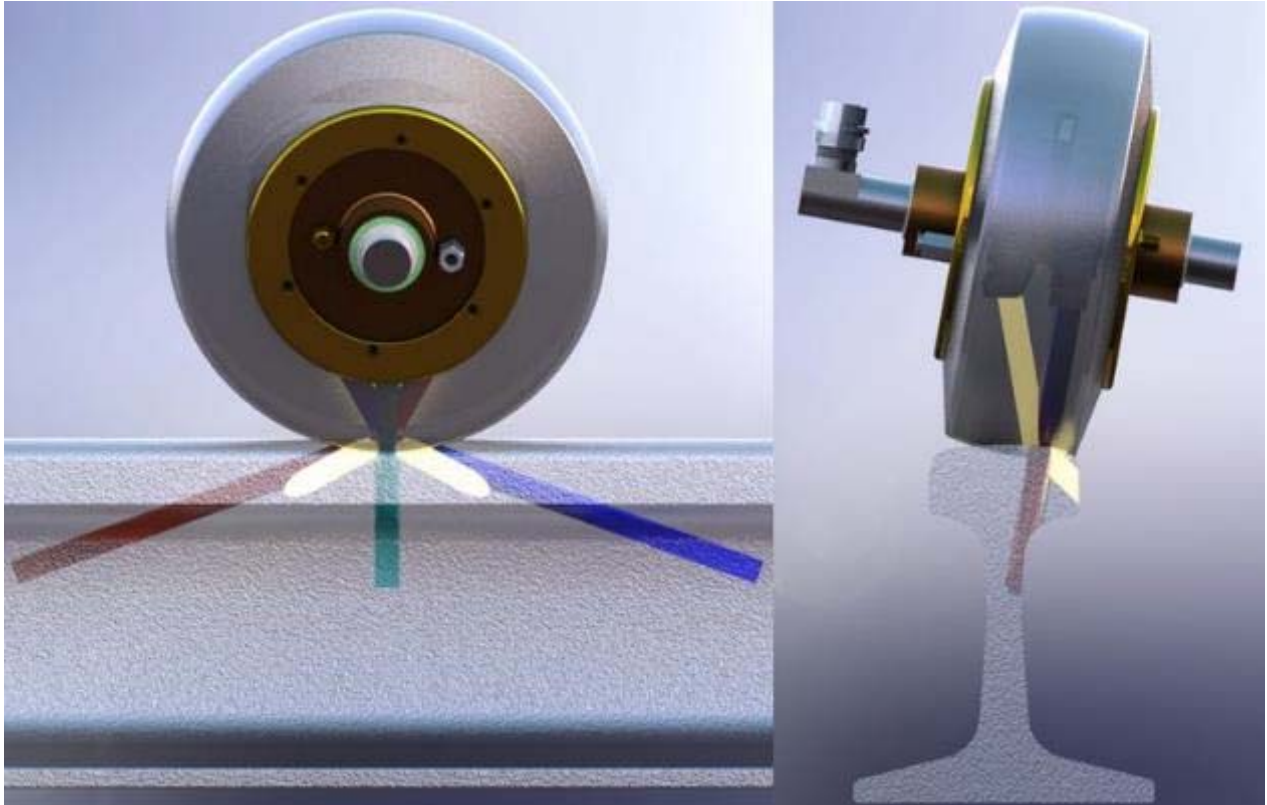
Tracer RSU

- Optimized to inspect worn gage corners that cannot be sufficiently inspected with perpendicular oriented RSUs due to contact loss
- 0° degree transducer is used to detect compound features of gage defects that are typically caused by WRI mismatches
- shear wave transducers are aimed at the gage corner to detect defects in the gage volume of the rail head

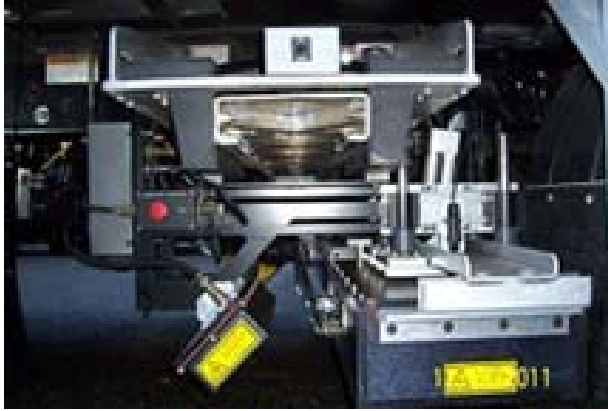
KLD Labs RailScope II LineScan System

Nordco offers the KLD Labs automated machine vision systems for capturing digital images of the rail head and web of all RailTest boxed indications.

KLD Labs' system incorporates the latest machine vision technology to collect and analyze high resolution images of the rail. The video cameras capture full longitudinal images of the rail section to aid in the capturing of defect detail.

The RailScope II sensor heads are mounted beneath the RFD vehicle either normal or at a 20 degree angle to view welds and joints on the gage side of the rail. The central computer and peripherals are housed inside the vehicle.

As the vehicle travels down the track, high-resolution images of the boxed indications are processed and stored on the system control computer. The image files will be transferred off the vehicle to cloud storage for data playback and analysis.

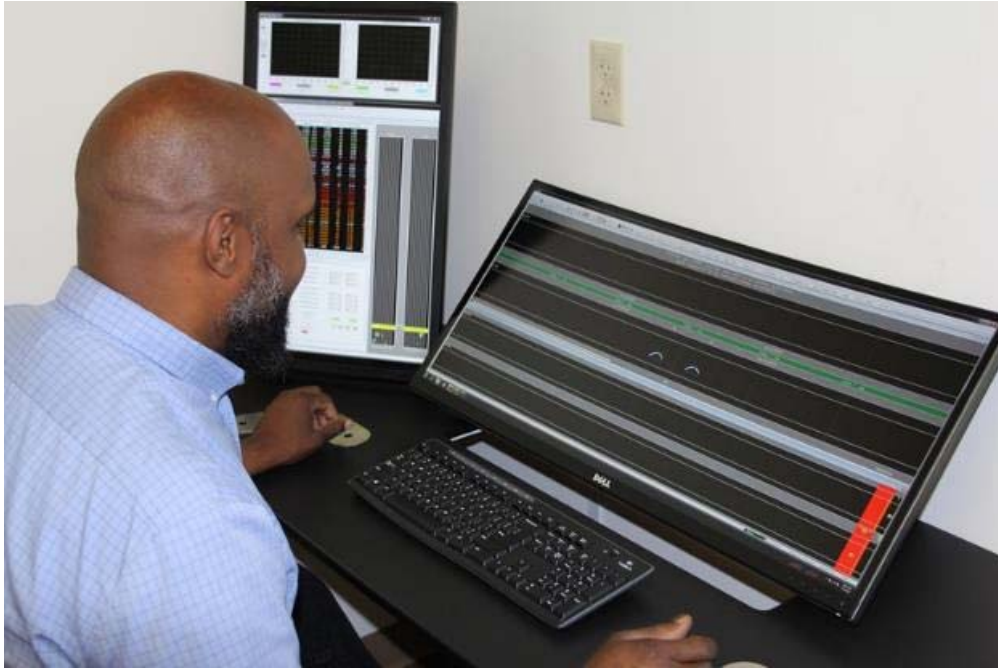
Nordco's Training Center Virtual Chief Operator Workstation with fully functional DSP
